Manhole Inspection Summary

Manhole # S59E__014MH

Insp Date: **7/24/08 10:22 AM**

Location Address: **4501 e lombard st**

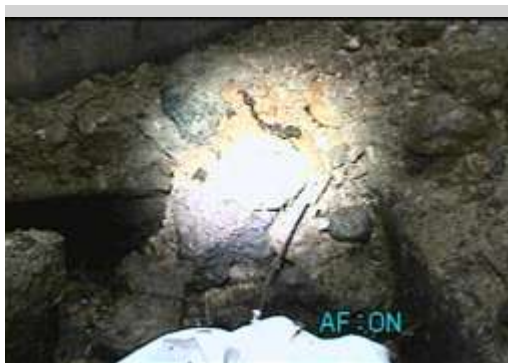
Defect 2

Condition: ☐ Sound ☐ Cracked ☐ Root Intrusion ☐ Deteriorated ☐ Leaks ☒ Debris

channel debris

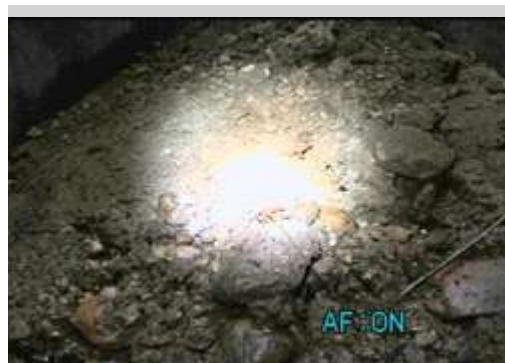
Defect 1

Condition: ☐ Sound ☐ Cracked ☐ Root Intrusion ☐ Deteriorated ☐ Leaks ☒ Debris

bench debris

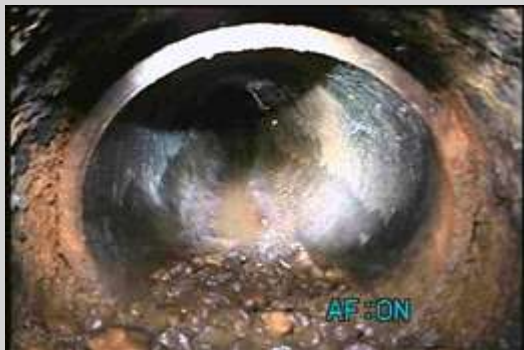
12 O'Clock Outflow

10 in. Circular Gravity Sewer
Pipe Out @ 12 O'Clock

Pipe Material: Clay ☐ Pipe Lined

Invert Depth: 6.61 (ft.) Flow Characteristics: None

Deposits: ☒ None ☐ Mud ☐ Sludge ☐ Debris ☐ Grease

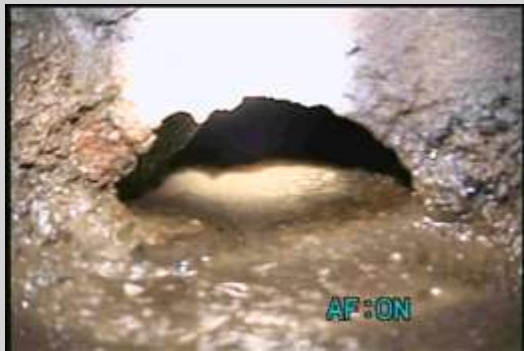
9 O'Clock Inflow

6 in. Circular Gravity Sewer
Pipe In @ 9 O'Clock

best shot cant see in pipe

Pipe Material: Clay ☐ Pipe Lined

Invert Depth: 6.29 (ft.) Flow Characteristics: None

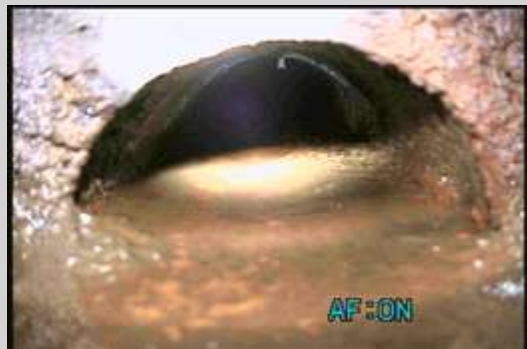
10 O'Clock Inflow

6 in. Circular Gravity Sewer

Pipe In @ 10 O'Clock

best shot

Pipe Material: **Clay** ☐ Pipe Lined

Invert Depth: **6.25** (ft.) Flow Characteristics: **None**
